# Little Cuyahoga River Restoration

A Little River with a Big History

# OCIT Little Cuyahoga River Restoration / Stabilization

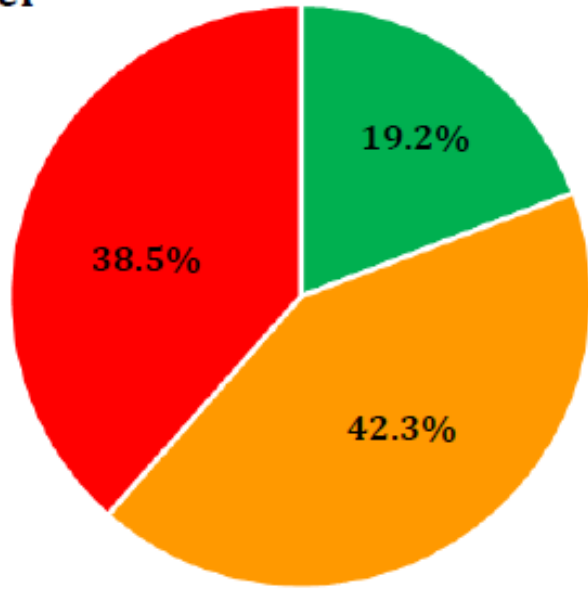
1996 & 2000  
Cuyahoga River  
mainstem  
(n=26 sites)

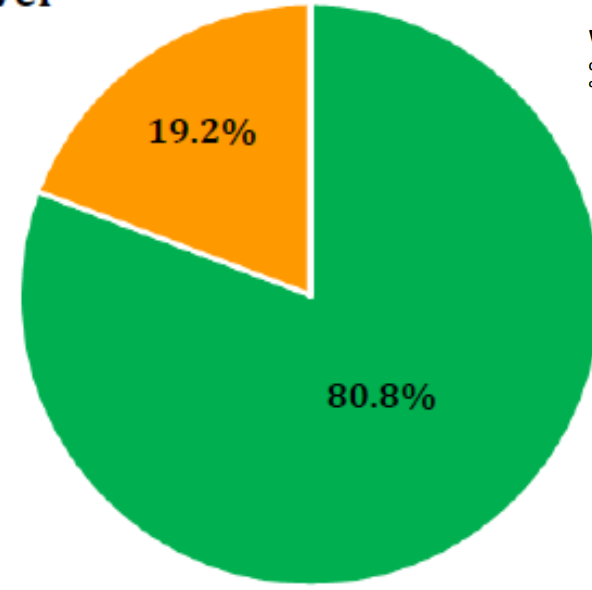
2017  
Cuyahoga River  
mainstem  
(n=26 sites)

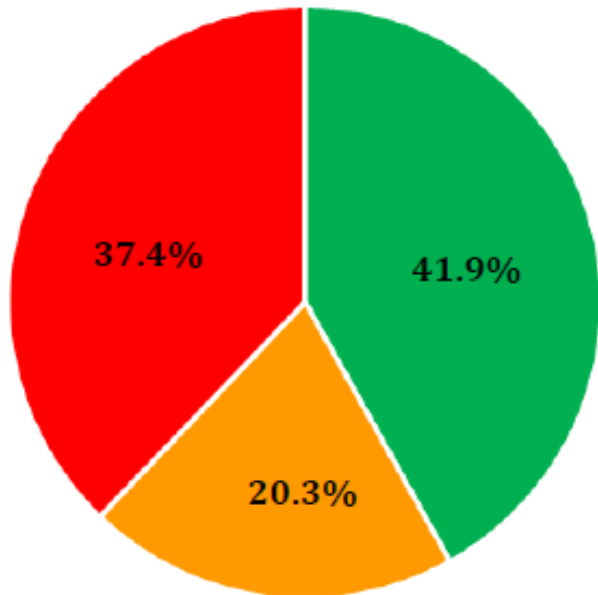
1996 & 2000  
Cuyahoga  
River  
tributaries  
(n=74 sites)

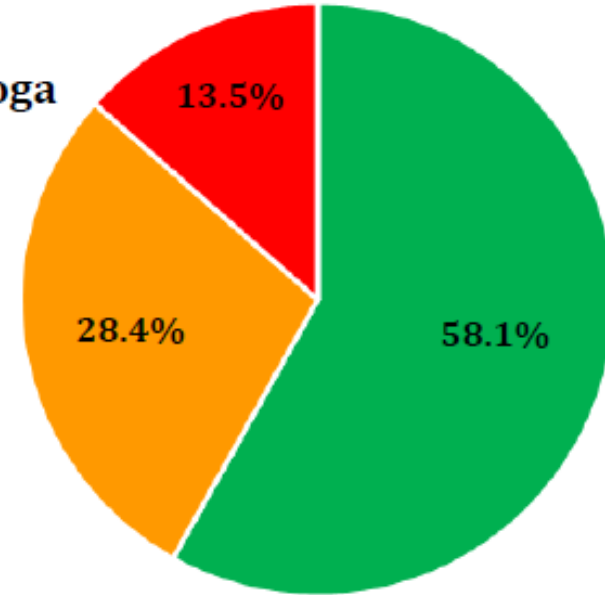
2018 Cuyahoga  
River  
tributaries  
(n=74 sites)

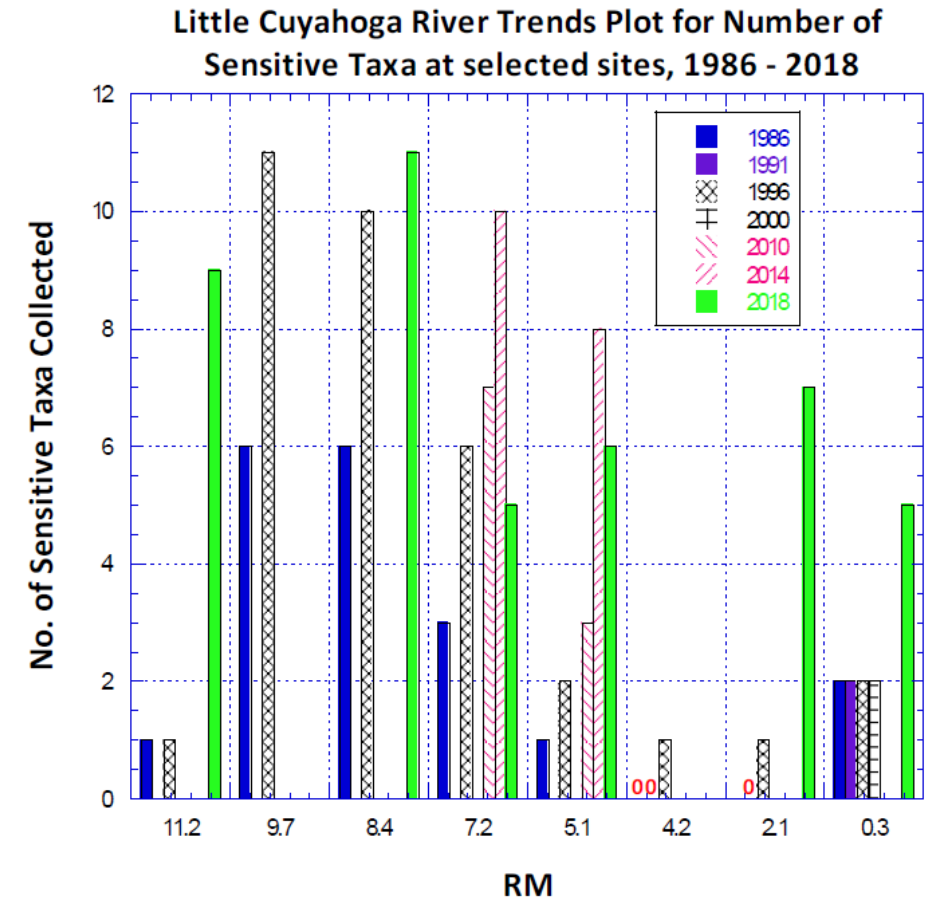
Figure 66 — Little Cuyahoga River Sensitive Taxa Trends, 1986-2018

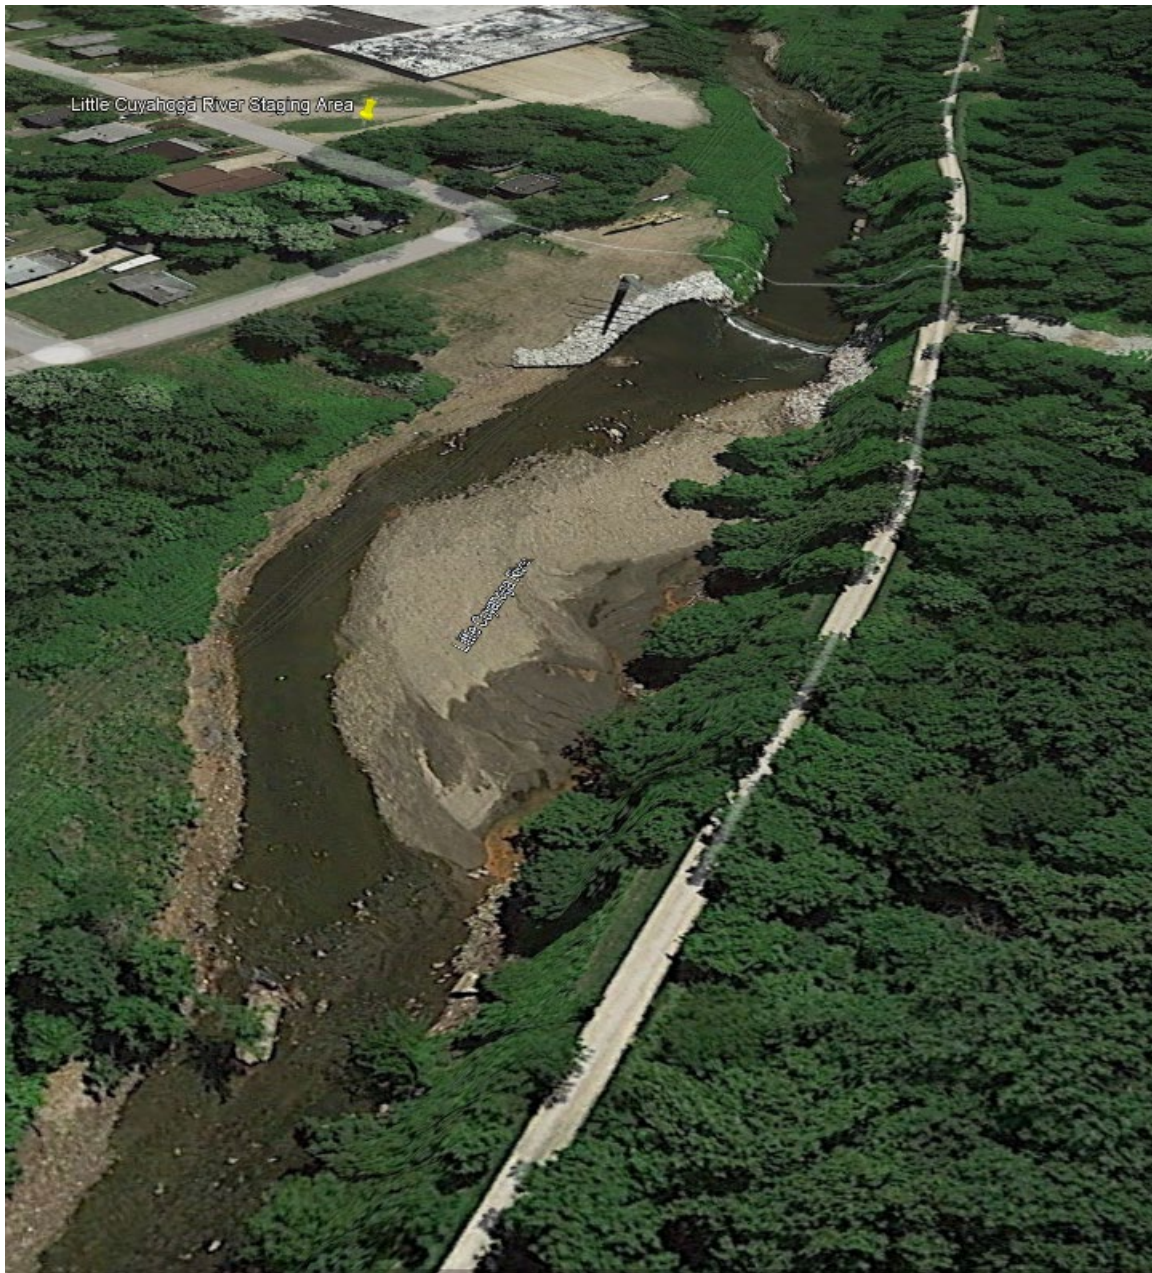
June 2014

Little Cuyahoga River Staging Area

Little Cuyahoga River

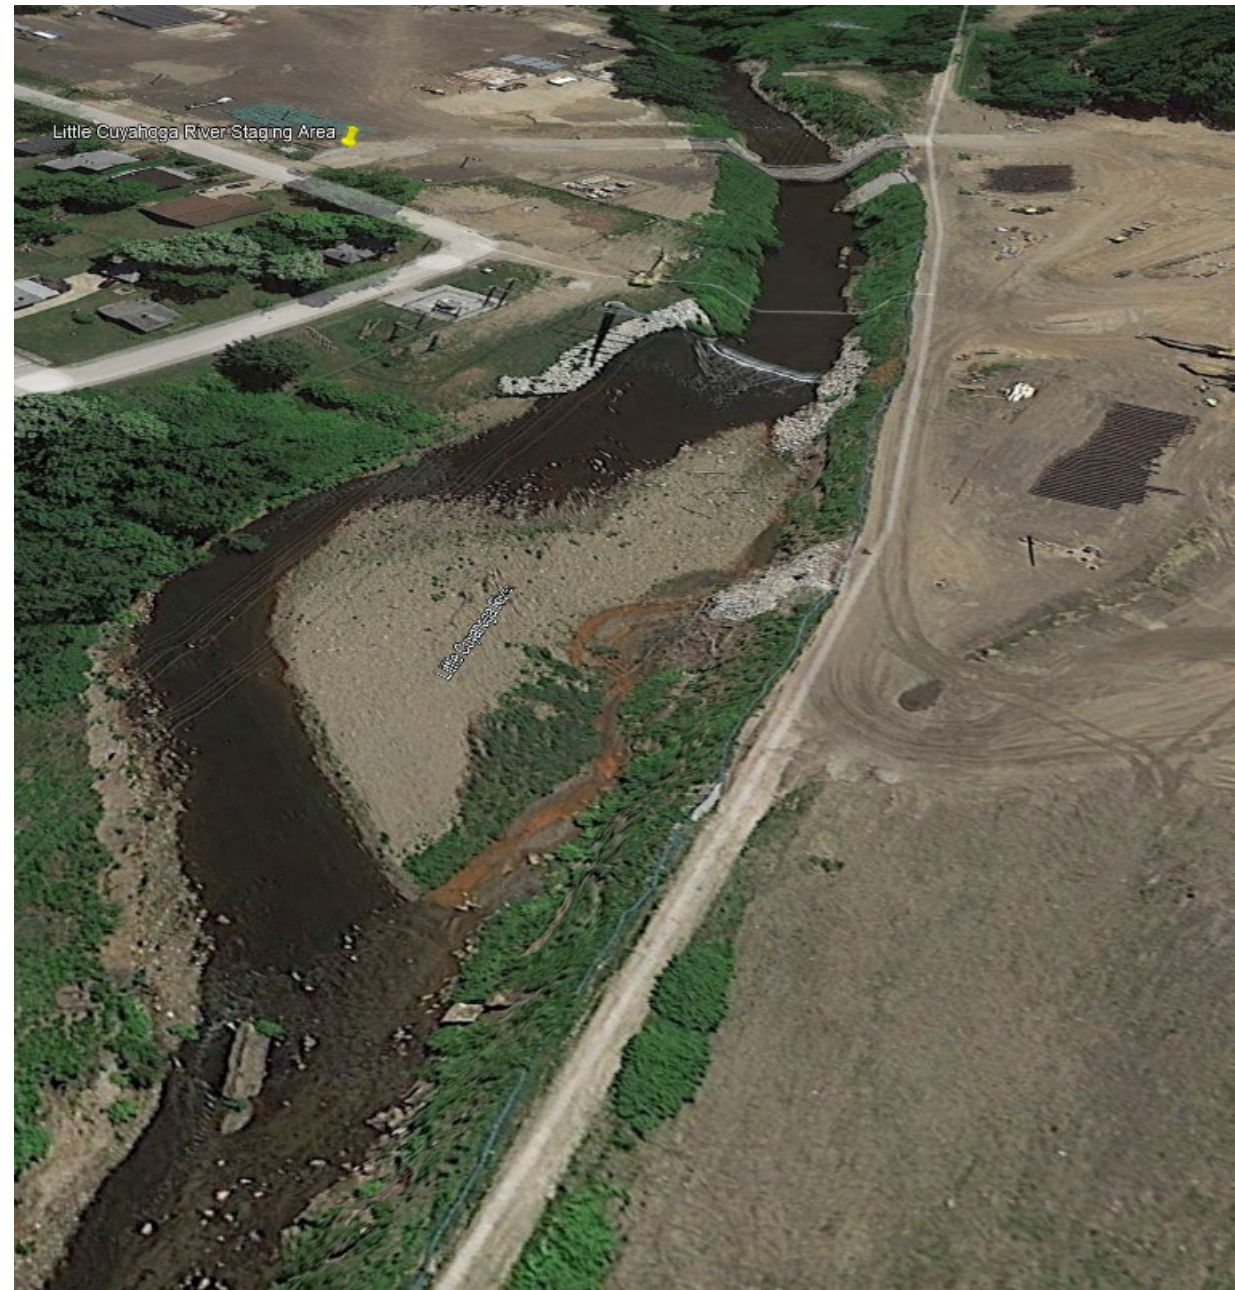
June 2016

Little Cuyahoga River Staging Area

Little Cuyahoga River

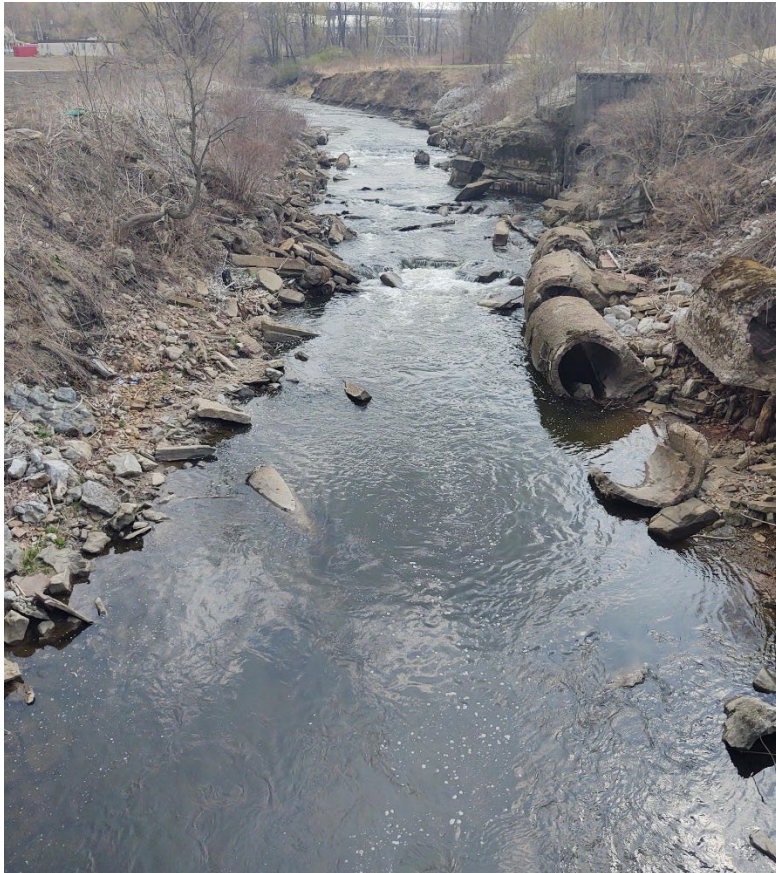
Presence of some legacy landfill/waste material on the southside which limited grading options

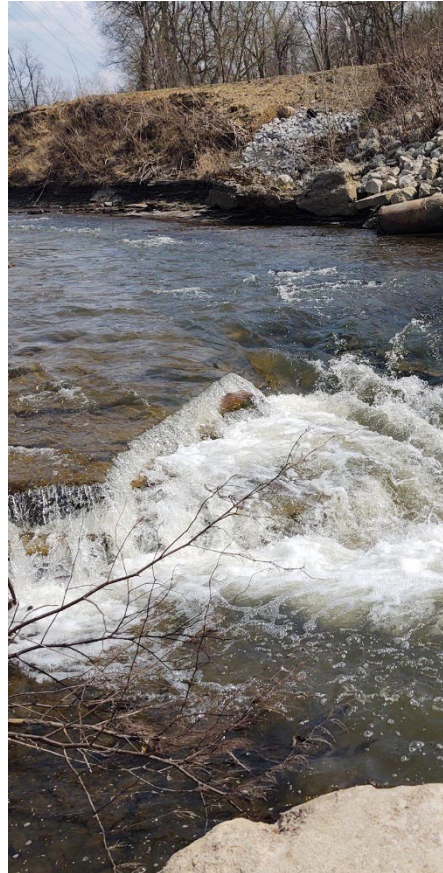
Concrete rubble, steep banks

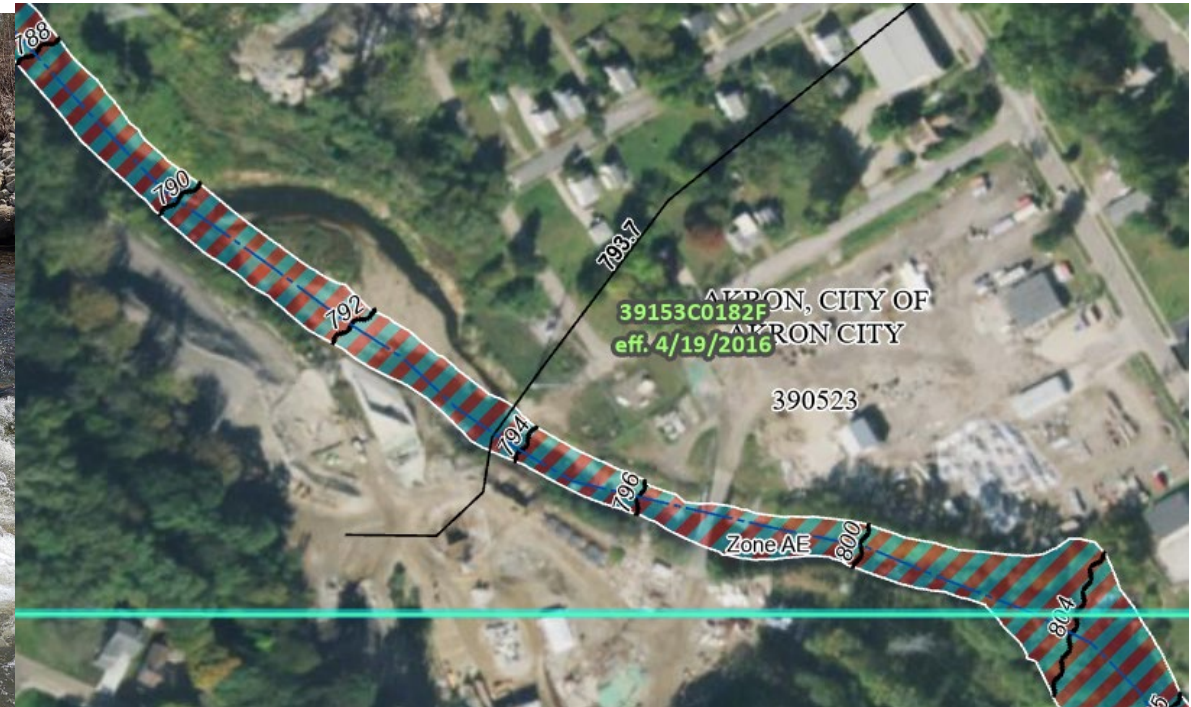
Fish Passage Barriers
